BMP Retrofit Pilot Projects

Quarterly Status Report No. 8

BMP Retrofit Pilot Projects in District 7 and District 11

CTSW-RT-00-047 March 1, 2000

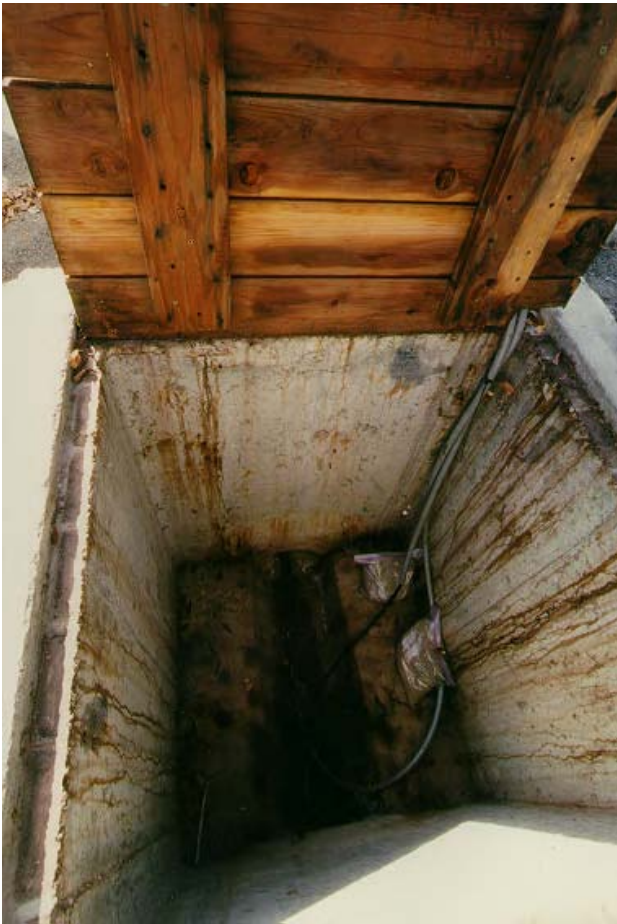
Photo 1. Wooden covers at Via Verde MCTT installation.

December 6: Monthly site inspection was conducted for December; preventive maintenance was performed on the wooden covers over the sampling boxes (longer deck screws were used to hold the sections together), also broken glass was removed from the site.

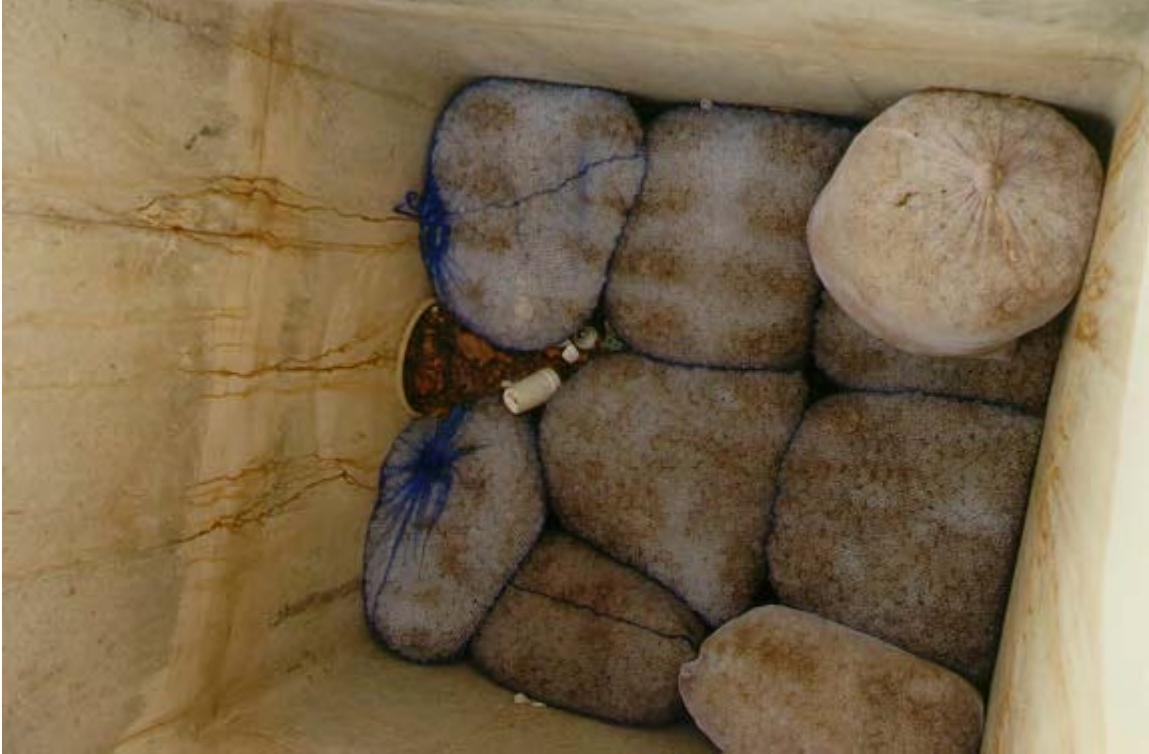
Photo 2. Litter collecting at inlet in grit chamber at Lakewood MCTT installation.

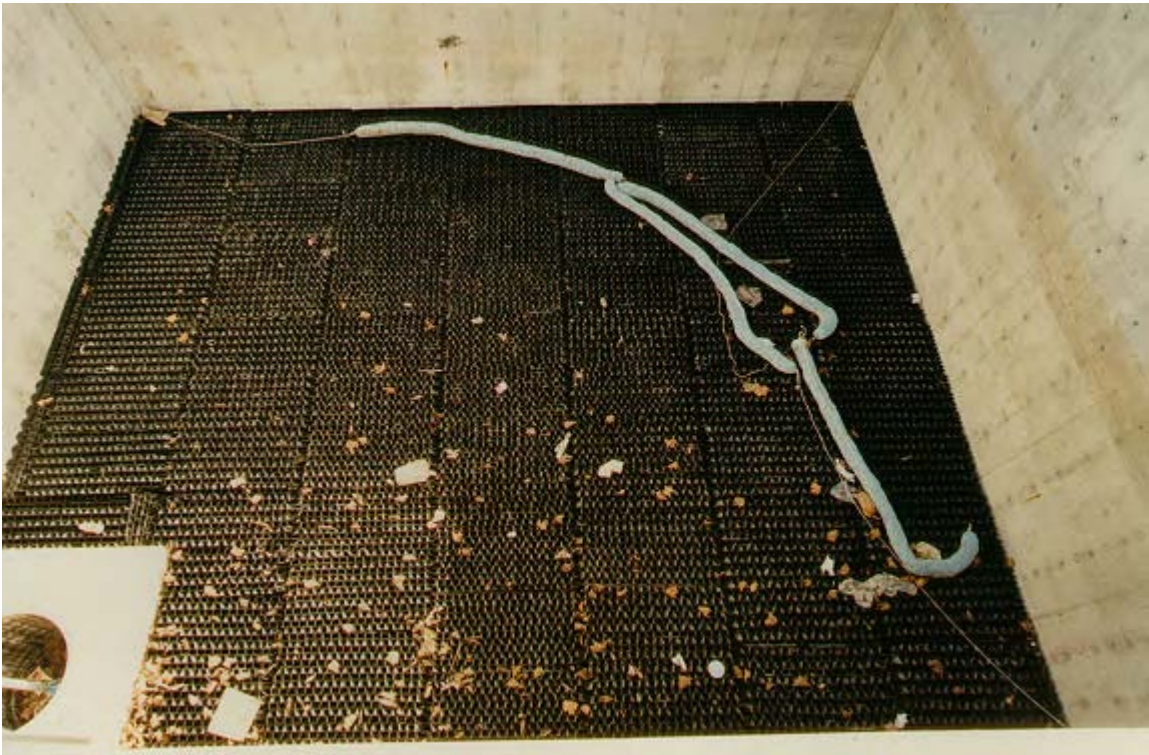
Photo 3. Main settling chamber at Lakewood MCTT installation.

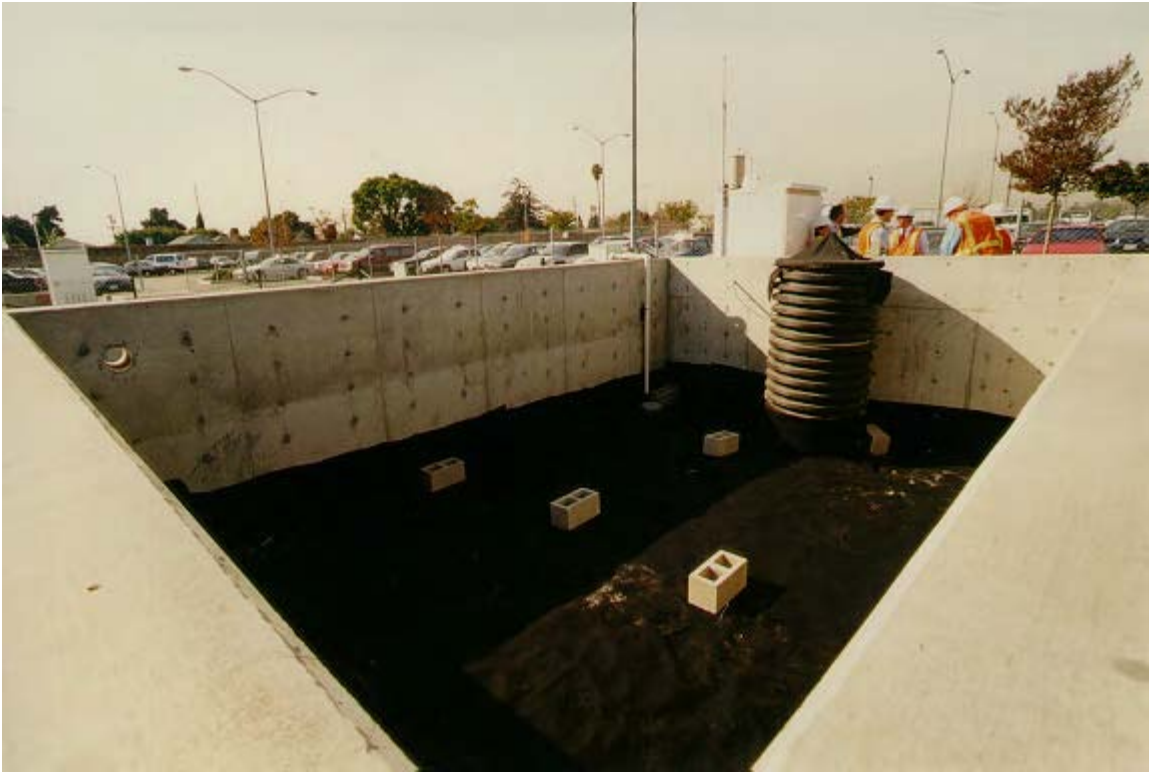
Photo 4. Filter chamber and fabric at Lakewood MCTT installation.
